# PROGRESS REPORT

PR 91570-510-10

For the Period of April 1, 1964, through April 30, 1964

## DEVELOPMENT OF A HYDROGEN-OXYGEN SPACE POWER SUPPLY SYSTEM

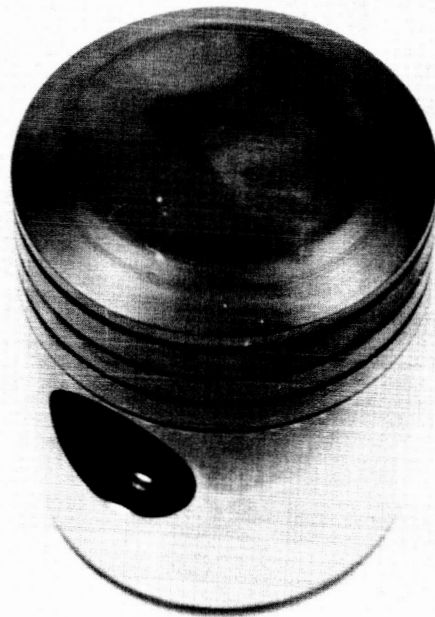
Fig. 4 - Piston After April 10 runs (Note  
Piston Dome Erosion)

The cylinder head of Fig. 2, page 5, of PR 91570-510-8, was found to direct oxygen flow very forcibly against the piston dome, causing erosion and extreme local heating. The appearance of the piston dome after a hot run can be seen in Fig. 4. This dome was modified to provide a shallower channel with slightly more clearance volume. Two timings were tried (see Table II). These tests are shown as entries 1 through 5 of Table I and in Figs. 5 and 6. An injector nozzle using three 0.017 in. orifices was used. Severe detonation and delayed combustion was experienced in top center operation with this nozzle, and a very high oxygen pressure was necessary. All of these tests were terminated by a failure of the upper cylinder "O" ring resulting in coolant leakage.
